## **LTPP Seasonal Monitoring Program**

Site Installation and Initial  
Data Collection  
Section 360801, Hamlin  
New York

**Report No. FHWA-TS-96-36-01**

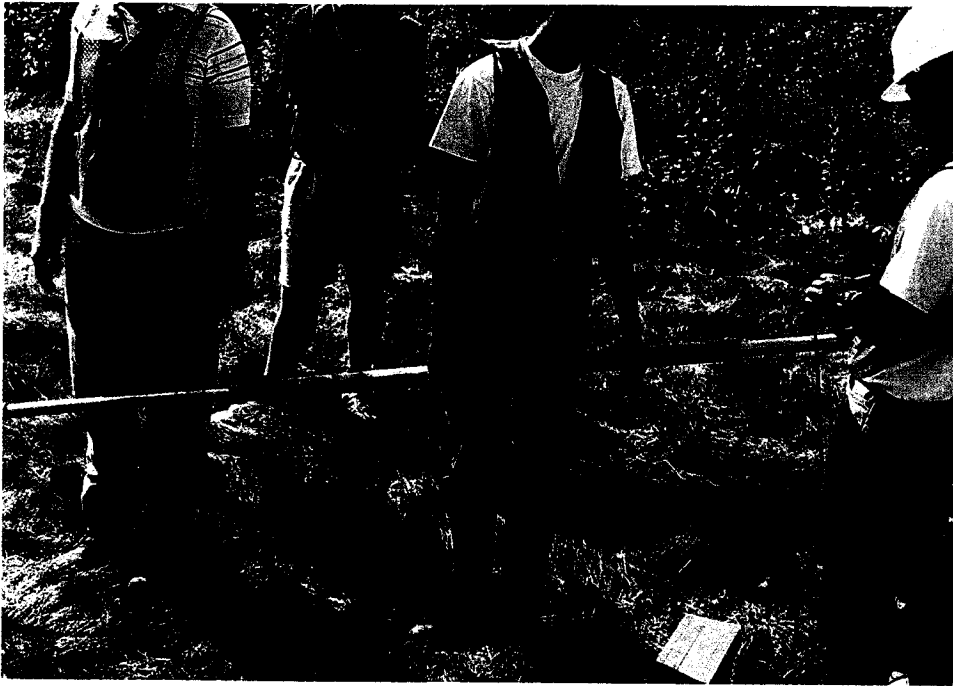
Figure E-3. Assembling the Piezometer

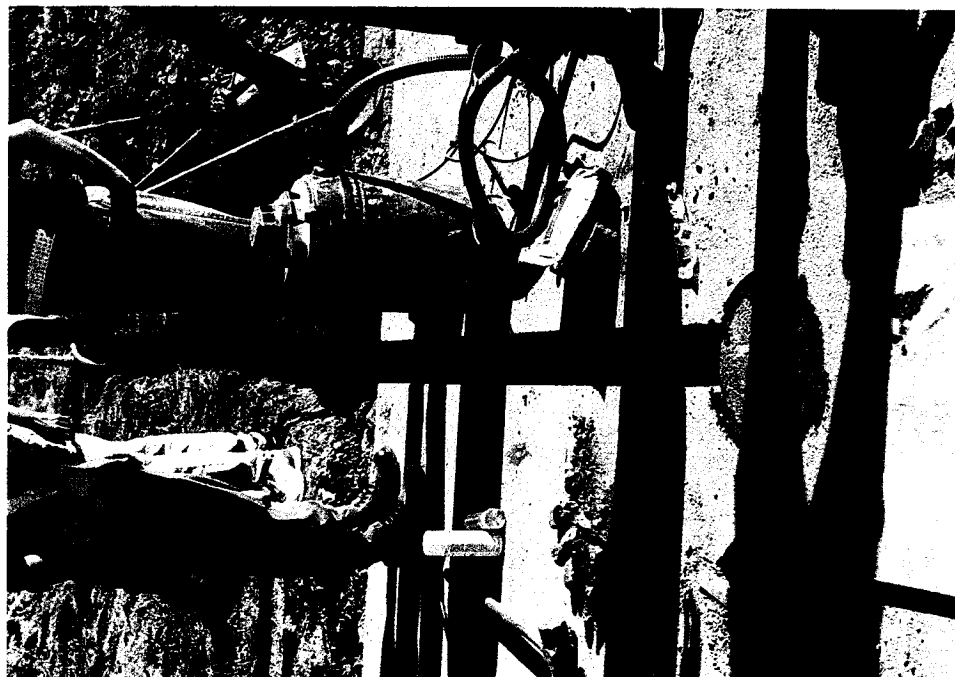
Figure E-12. Instrument Hole and Cable Conduit

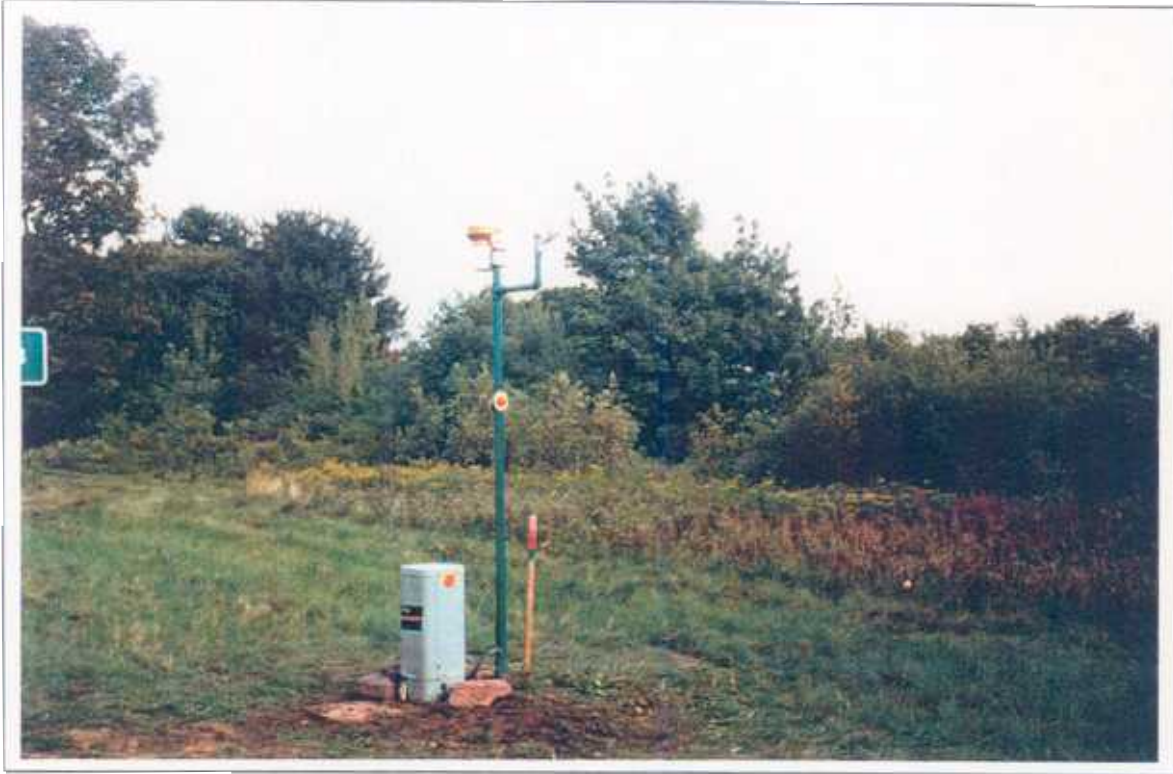
Figure E-13. Completed Weather Station and Equipment Cabinet

The pole for the rain gauge and air temperature probe were installed as per manual guidelines. The equipment cabinet was not installed until September 26, 1995 because there was not one available at the time of installation. A panel was wired to complete the required testing on the second day of installation. The cables from all instrumentation were placed in a sealed bag and buried to protect them from damage until the equipment cabinet was installed.
